## Case Study - Leak Seal & Soil Stabilization

### Repairing a Leak in a Retention Pond

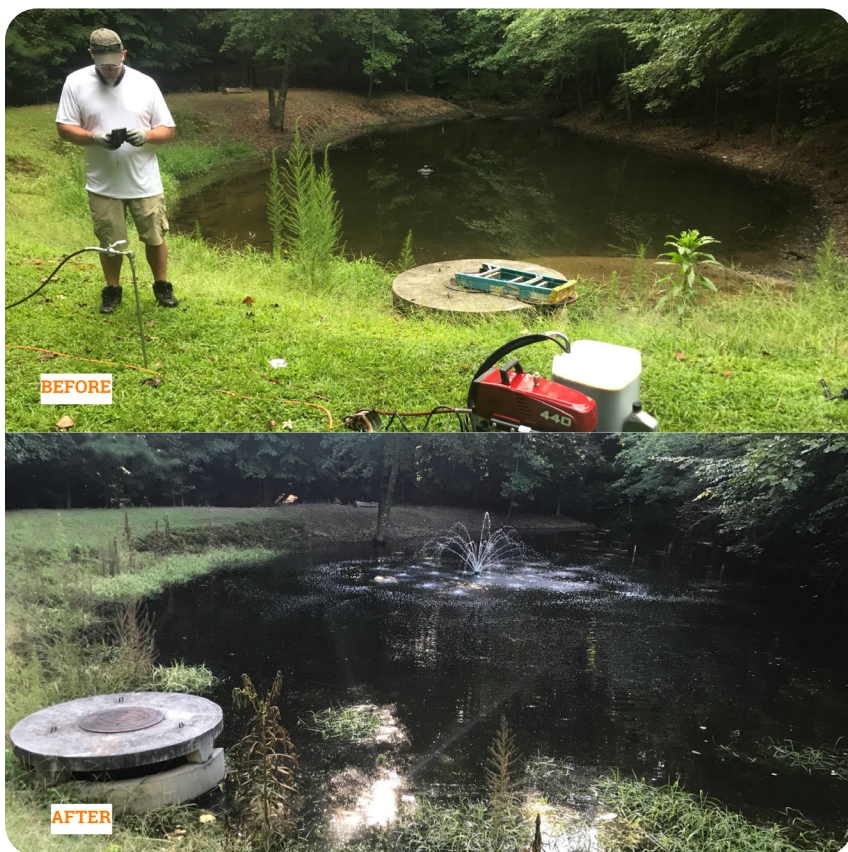
A property management company in metro Atlanta contacted SiteMix Pressure Grouting, LLC to address an issue with a neighborhood retention pond that was not holding water at the proper level. The customer reported that the water level was not running through the top of the concrete outlet control structure as designed but water was exiting on the other side of the earthen dam through the concrete outlet pipe. Upon inspection it was discovered that the pond water was piping along the outside of the concrete outlet pipe and leaking back into the outflow pipe through several bad joints in the concrete pipe.

AP Fill 700 was injected on 18-inch centers around the base of the OCS and outlet pipe in order to inject resin into the flow of the piping water. Specifically, the set time of the resin was reduced so that the piping water would take the resin the length of the pipe to the leaking joints. The goal was to have the AP Fill 700 react from downstream back up to the OCS. Crew members observed the pipe joints until AP Fill 700 presented and all the leaks stopped.

The job took one day to complete and less than 50 gallons of resin. Within three days the pond was at full pool and the management company and neighborhood residents were very satisfied with the work. treatment plant were extremely happy with the results.
