Case Study - Leak Seal & Void Fill

Repairing a Footing in a Detention Pond

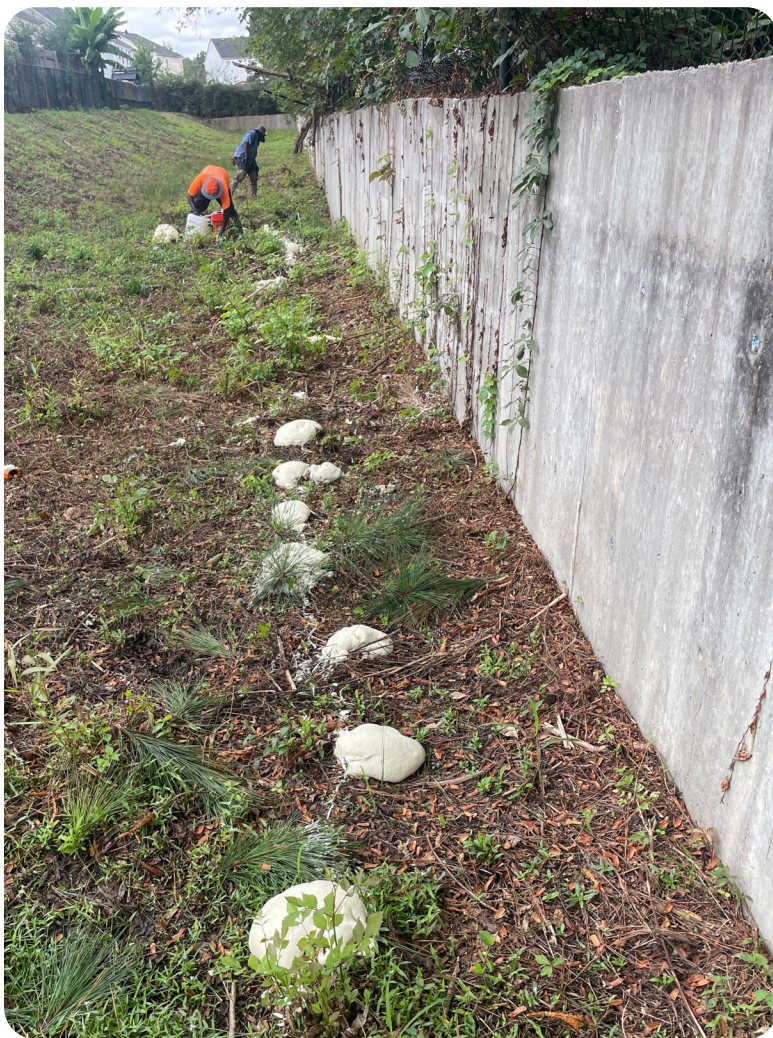
A general contractor working with a homeowners association reached out to SiteMix Pressure Grouting, LLC about a detention pond wall that was leaking along the footer in several places. A detention pond is designed to collect rainwater and then let it drain slowly in a controlled manner. But in this case, water was washing out quickly in an uncontrolled manner in multiple spots under the footing.

First, the crew injected AP Fill 720 along 150 feet of the wall, installing approximately one gallon underneath the footing every two feet. Next, they installed another 75 gallons spot treating larger voids.
